**THE HISTORY OF TERRA-COTTA GLAZE-FIT TESTING AND ARTIFICIAL WEATHERING
METHODOLOGIES AND A COMPARATIVE TESTING PROGRAM OF THEIR IMPACT ON
GLAZE FAILURE**

Submitted in partial fulfillment of the requirement for the degree
Master of Science in Historic Preservation

Columbia University

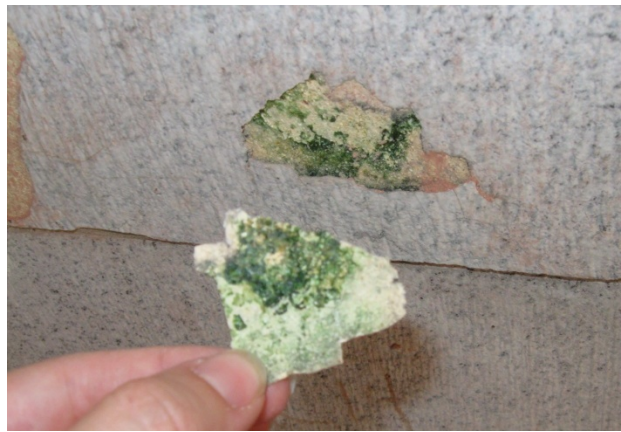
Figure 5 (right): Glaze spall, furthered by biological growth beneath the glaze surface. Source: Joan Berkowitz

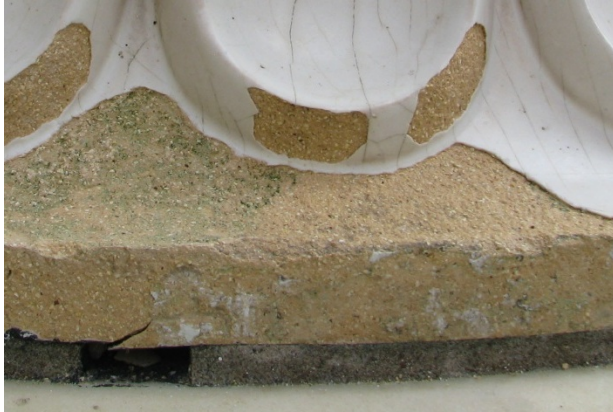
Figure 8: Peeled glaze, without clay body loss. Source: Xsusha Flandro

Shivering, another form of glaze loss, may appear similar to spalling, in that it also entails chip-like pieces of glaze separating from the terra-cotta unit. However, there is a difference between these types of defects- shivering does not involve the loss of clay body, but rather only glaze loss, as if it “peels” off the clay surface. It is caused by excess amounts of silica and/or salts in the clay body, and is exacerbated by compression forced upon the unit.¹⁵ Some writing also describes shivering as glaze peeling.

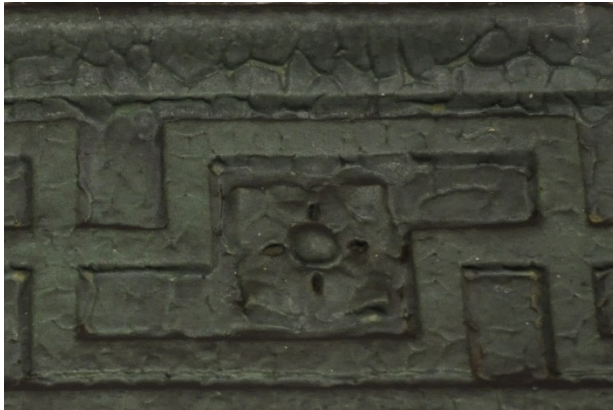
Figure 9: Crawling on a glazed surface

Crawling is similar to crazing in that involves separation of the glaze from the body, but instead of cracking during final cooling or weathering, the glaze contracts during the actual firing or immediately following cooling period. This results in unglazed portions of clay body which are surrounded by coalesced glaze, rather than sharply fragmented edges.

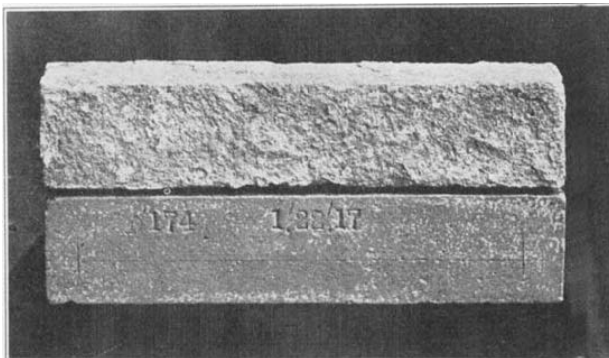
Figure 11: Grog (above) and slag (below) bodies after boiling cycles. Source: *Journal of the American Ceramic Society*

Samples were boiled for three hours in a sodium sulphate solution, and then dried at room temperature for 48 hours. This cycle was repeated with the hope of causing visually evident damage. After 15 repetitions, the body prepared with grog showed signs of flaking, but the slag body resisted 34 cycles.

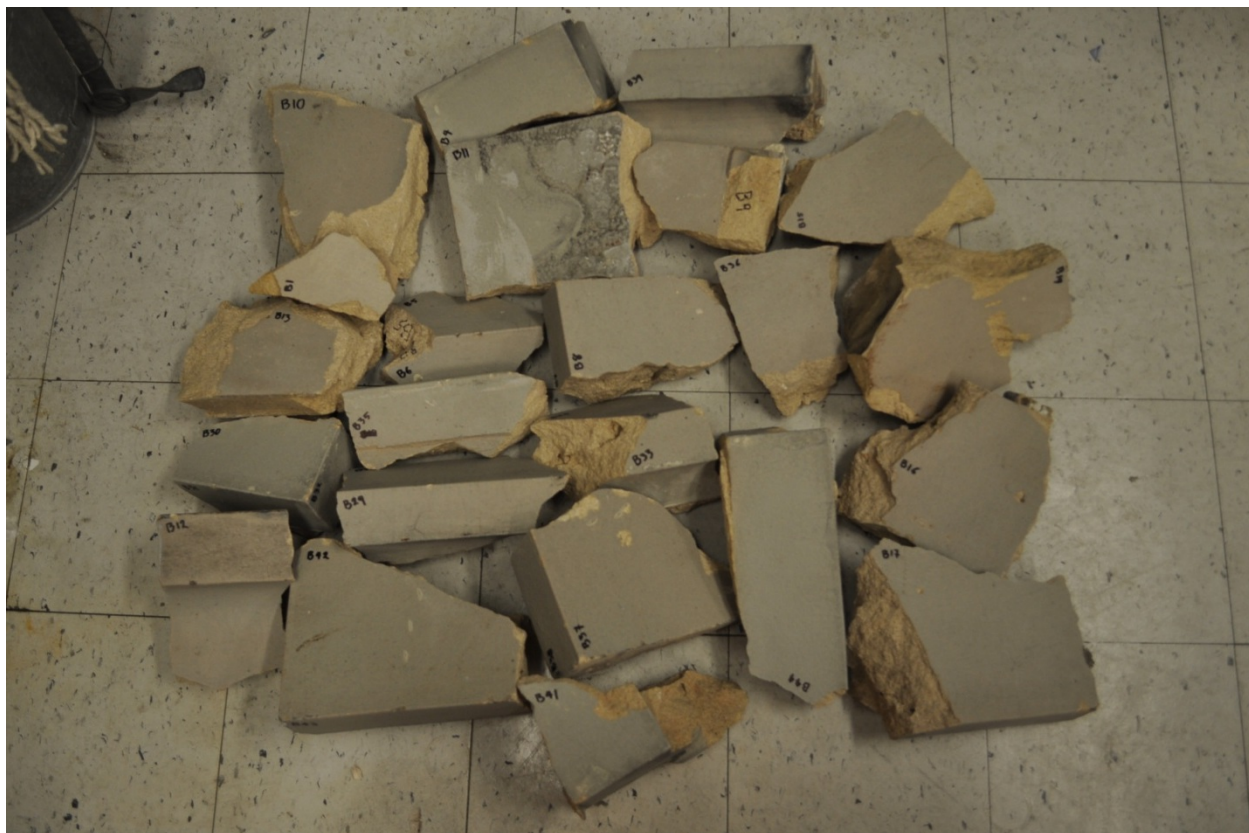
Figure 23: Samples from group B before testing

Sample B specimens are glazed with a matte, 2.5Y N7/0 “light gray” glaze, with no specks or mottling. Most areas show signs of crazing. The clay body is 5Y 8/3 “pale yellow,” with grog of 2.5Y 8/6 “yellow,” 2.5Y N3/0 “very dark gray,” and 2.5Y 8/4 “pale yellow” colors. Grog pieces ranged in size from 0.29mm to 2.21mm across, and voids ranged from 0.22mm to 0.62mm wide and 0.70mm to 2.07mm long. Samples which were subjected to testing were broken on-site by construction workers- only a single piece was cut for cross-sectional examination.

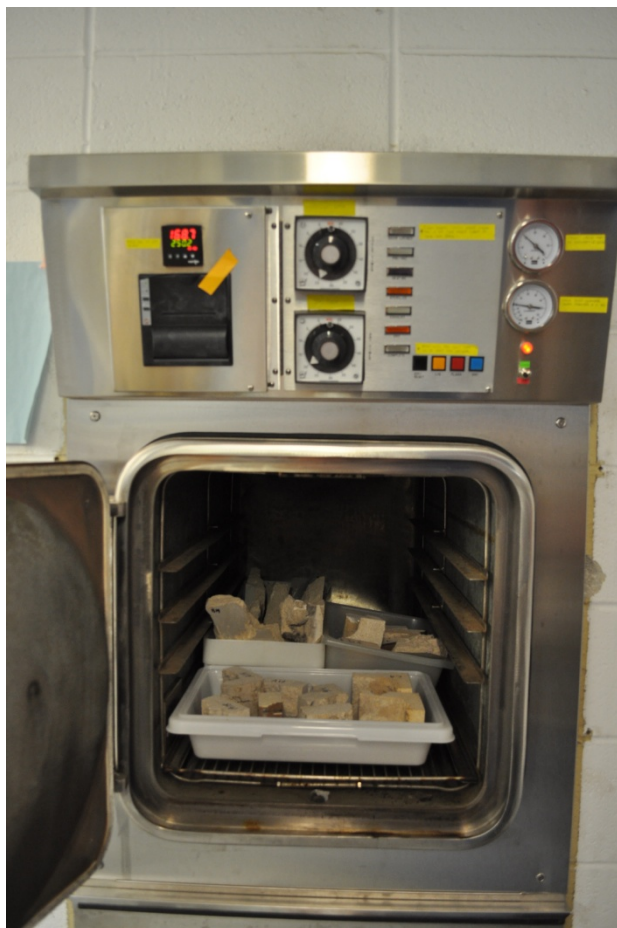
Figure 56 (left): Samples in the autoclave, before procedure

1. Insert samples into chamber of autoclave. Use plastic containers as necessary to prevent abrasive damage to interior metal surfaces.
2. Firmly lock door and set test to run at 250°F and 20 pounds per square inch for 60 minutes.
 - Although historic tests prescribed using 150 psi, 20 psi was the highest pressure available due to the physical limitations of the building's steam supply. The implications of this difference will be discussed in the results.
3. Because the steam application leaves the samples wet, dry them in an oven at 217°F for 4 hours.
4. Test is only performed once, and does not need to be repeated cyclically.
 - A single autoclave test was said to closely correlate with the behavior of a terra cotta unit that was weathered naturally for one to three years.

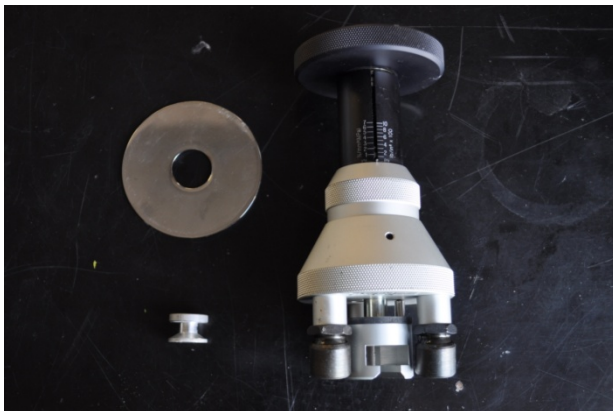
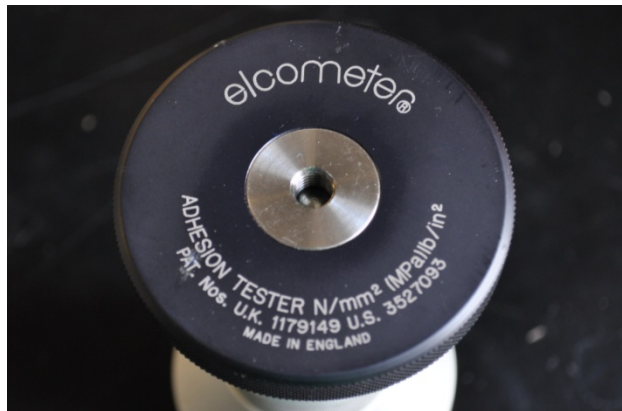
Figure 65 (left): The Elcometer 106, bearing ring, and loading dolly
Figure 66 (right): Model information at the top of the Elcometer

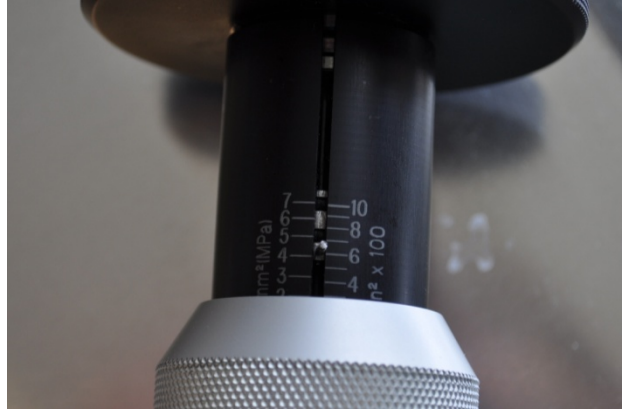
Figure 67 (left): The claw and feet of the Elcometer, as loaded onto the dolly and bearing ring
 Figure 68 (right): The force readout scale, in $\text{lb/in}^2 \times 100$

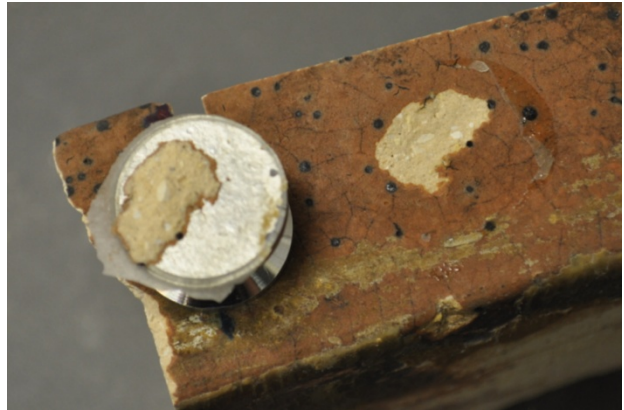
Figure 69: Failure by manual prying on samples E4 and E5

At the beginning of testing, a number of dollies were accidentally epoxied onto surfaces upside-down, preventing the Elcometer claw from properly fitting.⁴⁷ In order to remove these dollies from the samples, they were heated at approximately 350°F for 1 hour, which slightly softened the epoxy. The dollies could then be pried off of the terra cotta surfaces with pliers. When the dollies were re-adhered, a new location was selected, in order to prevent overlap with any epoxy remnants on the surface. In the process of prying off the dollies, however, three samples reached failure: B10, E4, and E5.

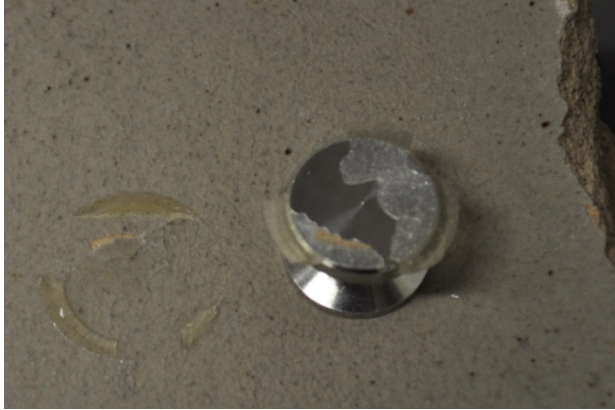
Figure 70: Failure by manual prying on sample B10

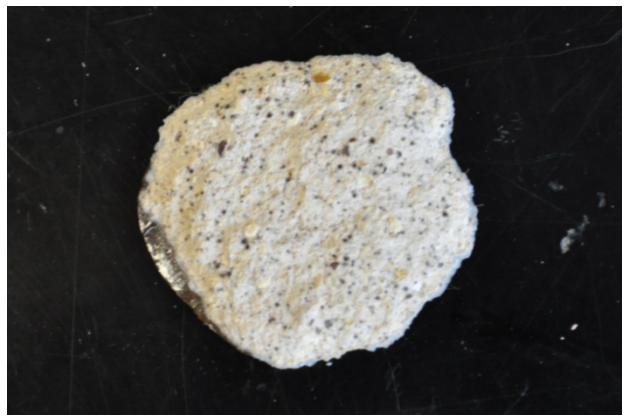
Figure 71: Material removed from a dolly, including intact epoxy, glaze, and clay body, after a successful adhesion pull test

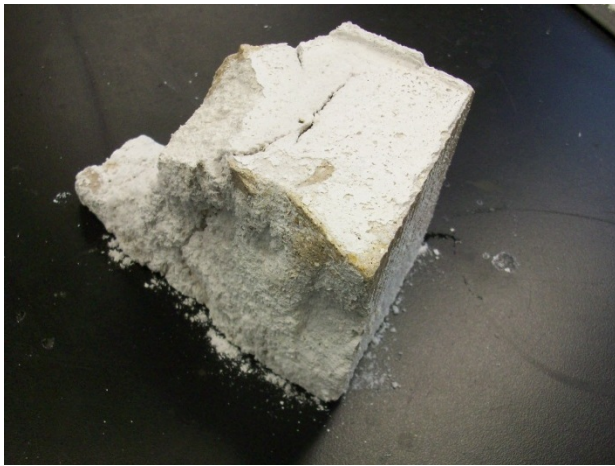
Figure 73: Typical sodium sulfate deposits

Upon air drying, all samples subjected to the boiling salt bath test had sodium sulfate deposits on their unglazed surfaces, in the form of a light powder. This was far more evident on sample group B; it is unknown if the abundant salts were caused by the material make-up of this sample, or simply because the surfaces were roughly broken, not cut like other sample groups. Historic tests never mentioned these deposits in descriptions of the experiments carried out, but the reason for their presence is easily understood.

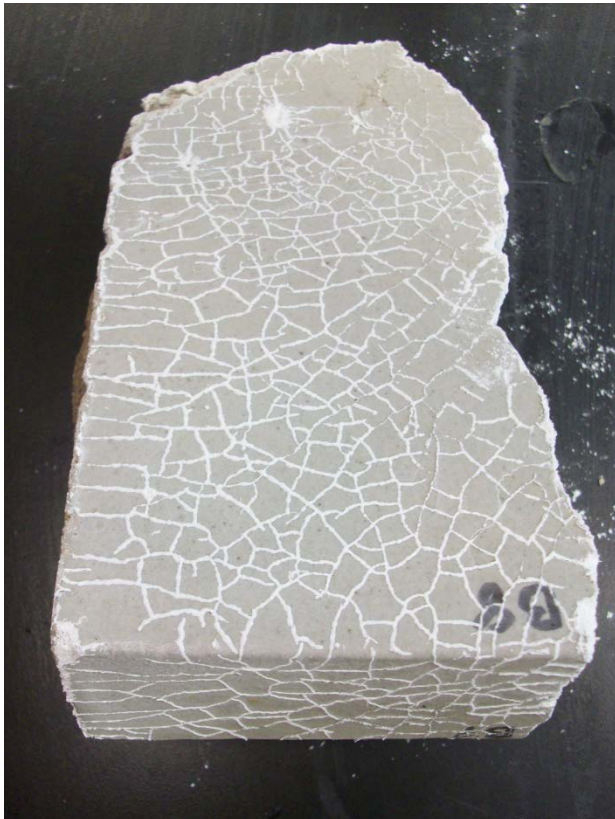
Figure 76 (left): Sample B8 after 15 testing cycles

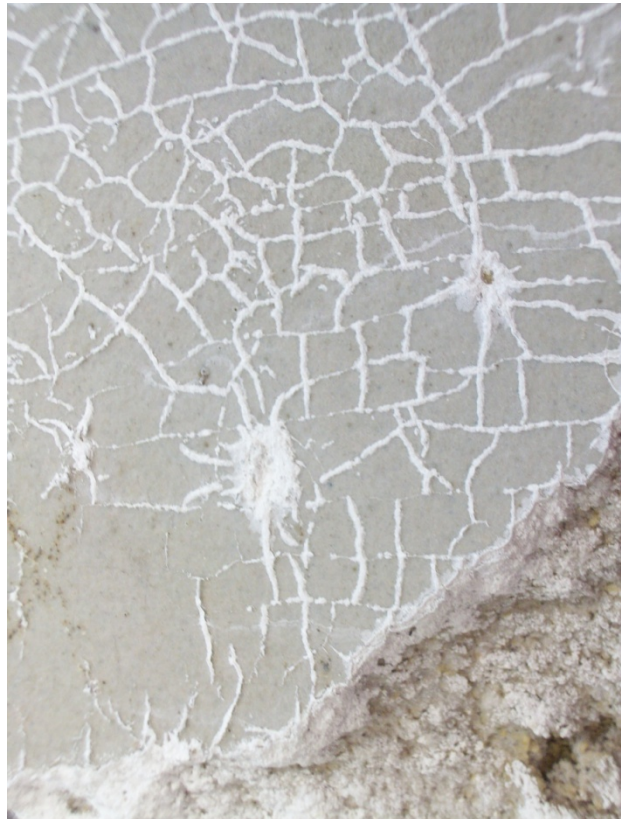
Figure 77 (right): Salt deposits concentrated around clay body exposures

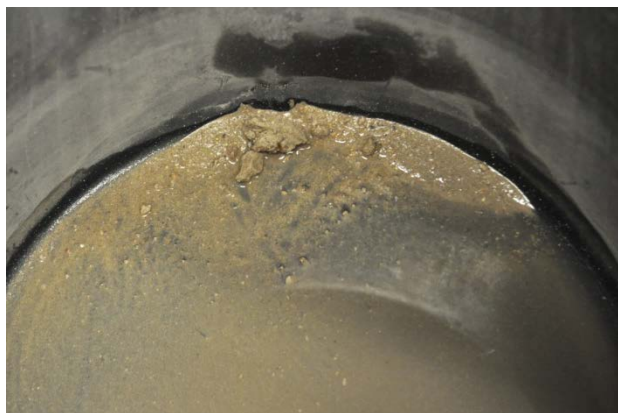
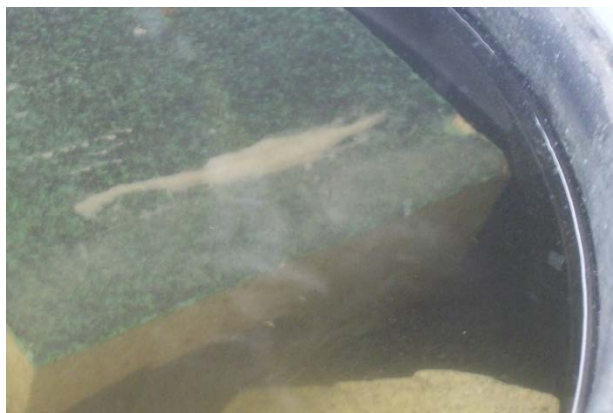
Figure 84 (left): Sediment in the bottom of the pot after testing
Figure 85 (right): Sediment seen on a sample surface

Upon testing completion, a small amount of sediment remained in the bottom of the pot used for boiling. It is unknown if this was due to sample disintegration, or simply bits of clay body that were already loose before testing, which were knocked off of the samples during the procedure.

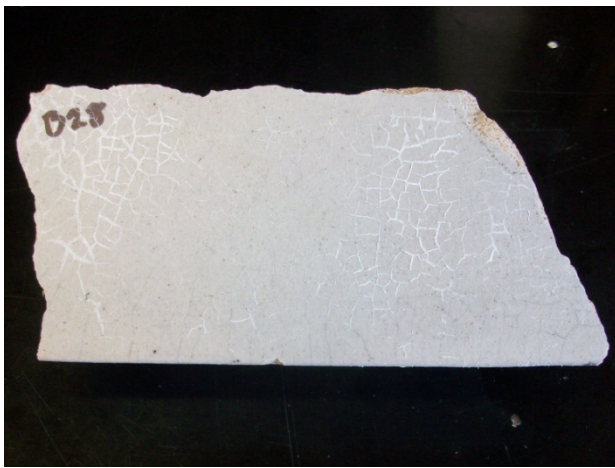
Figure 87 (left): Salt patterns over crazing lines on sample B28

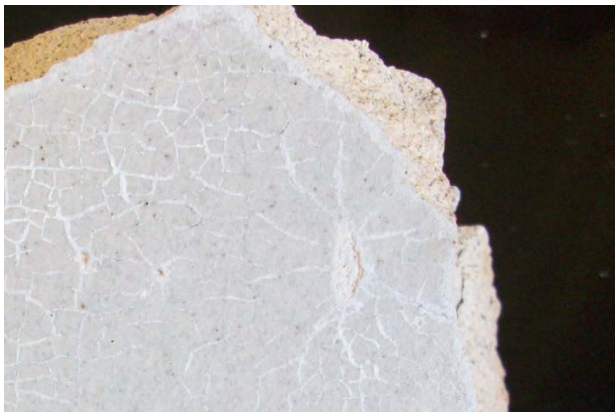
Figure 89 (left): Salt deposits around a broken glazed surface on sample B34

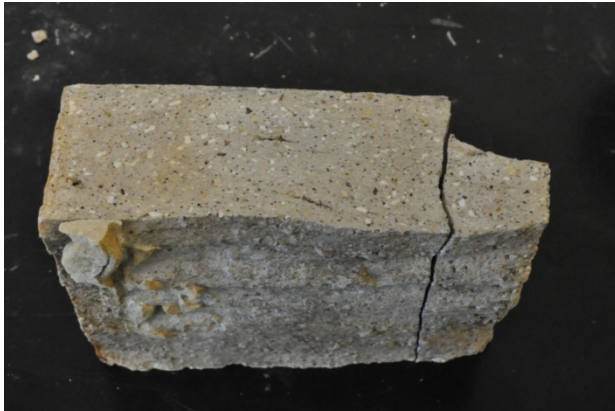
Figure 93 (left): Sample A31 cracked during testing

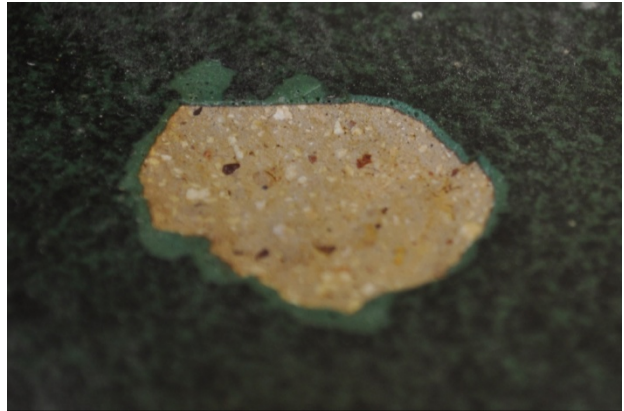
Figure 94 (right): Visible cross-section of glaze on sample C9

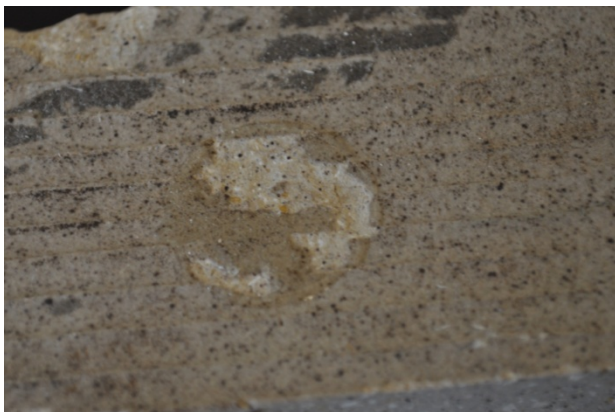
Figure 97 (left): Partial failure on sample A11

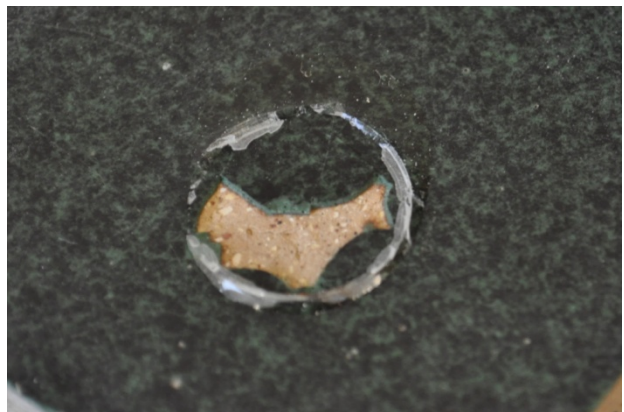
Figure 98 (right): Partial failure on sample C14

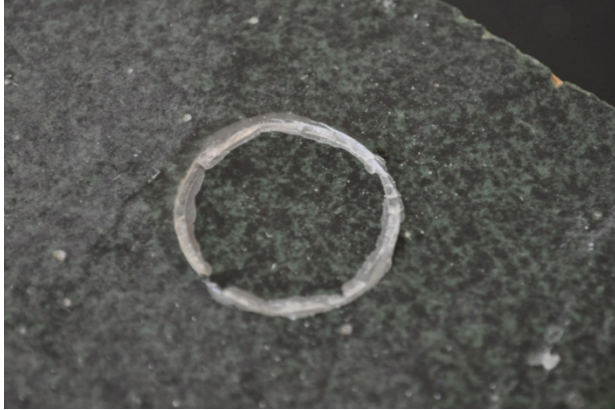
Figure 99 (left): Failed pull test on sample C13
